Niguel Shores Rock Revetment Repair & Maintenance Project

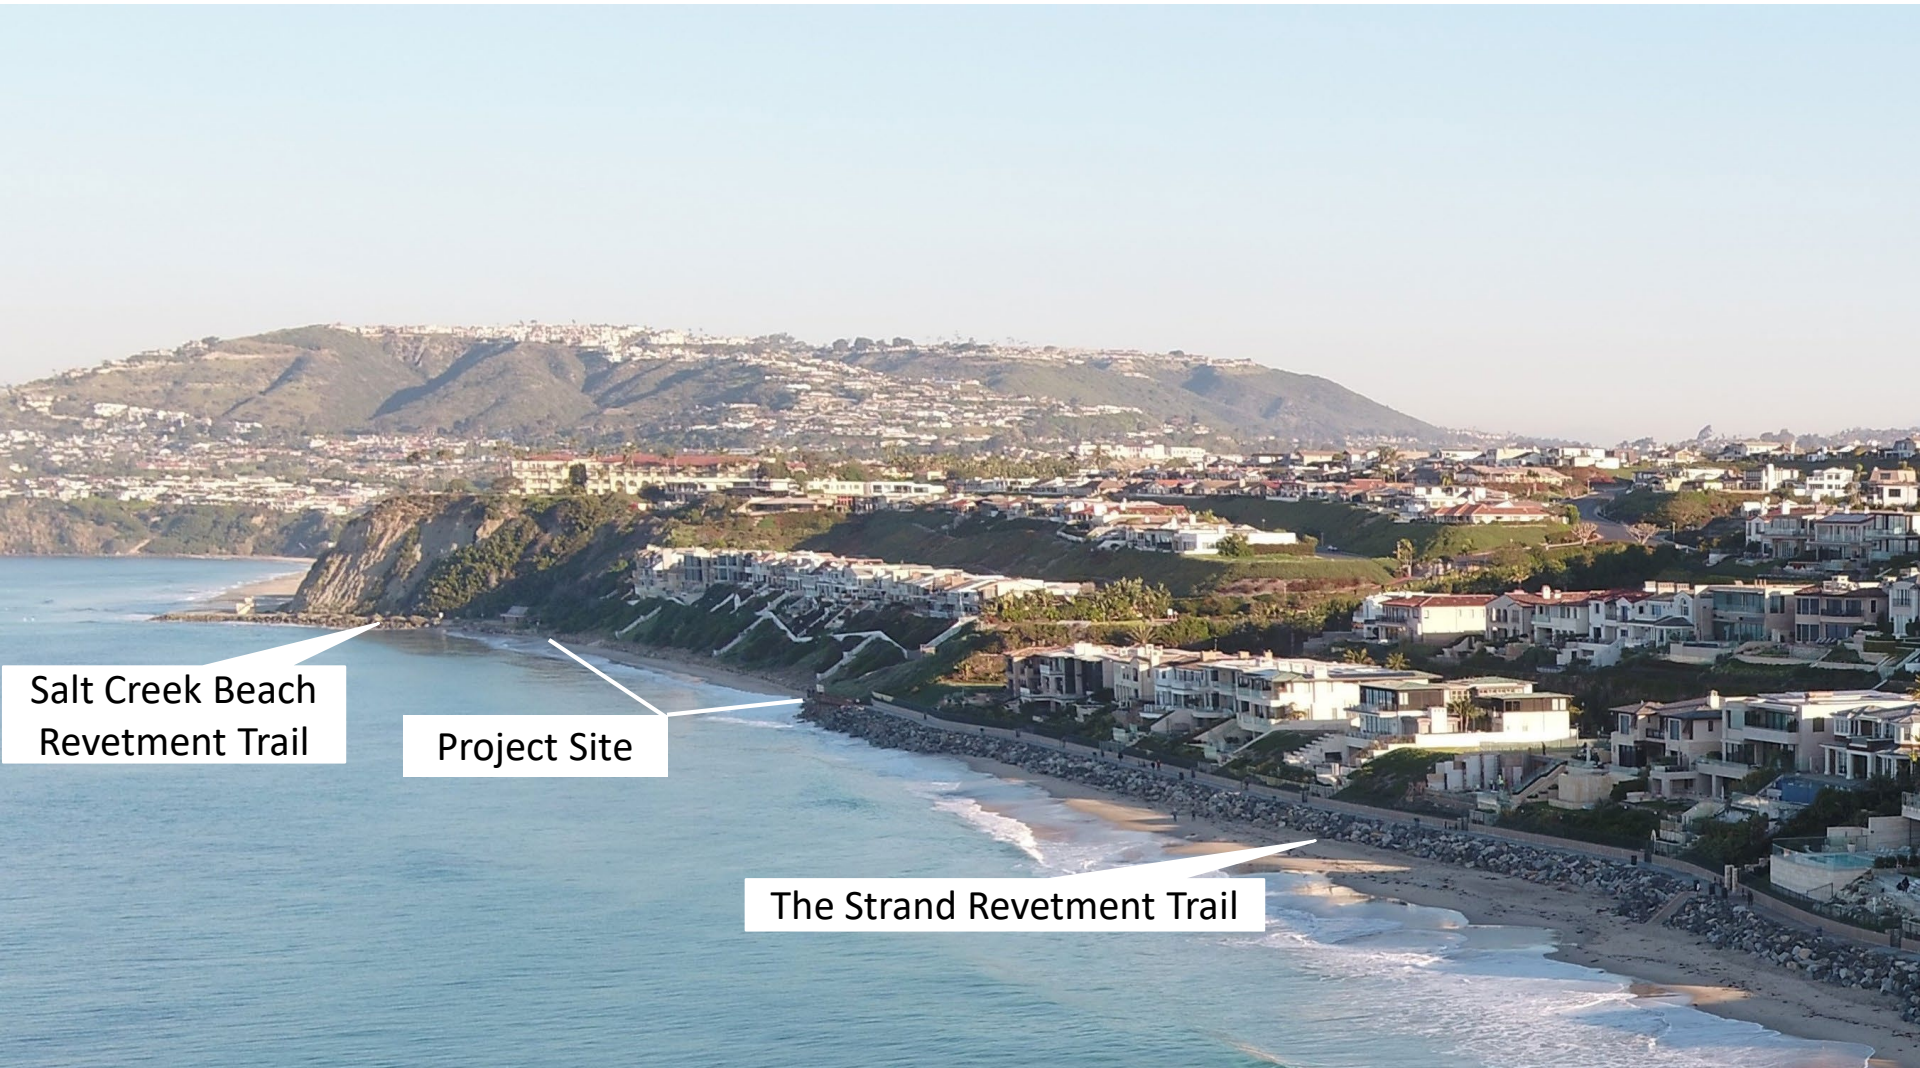
Existing Revetment and Beach Conditions

Entire length of shoreline armored since the 1960's, with upgraded revetments located up and down coast of the project site

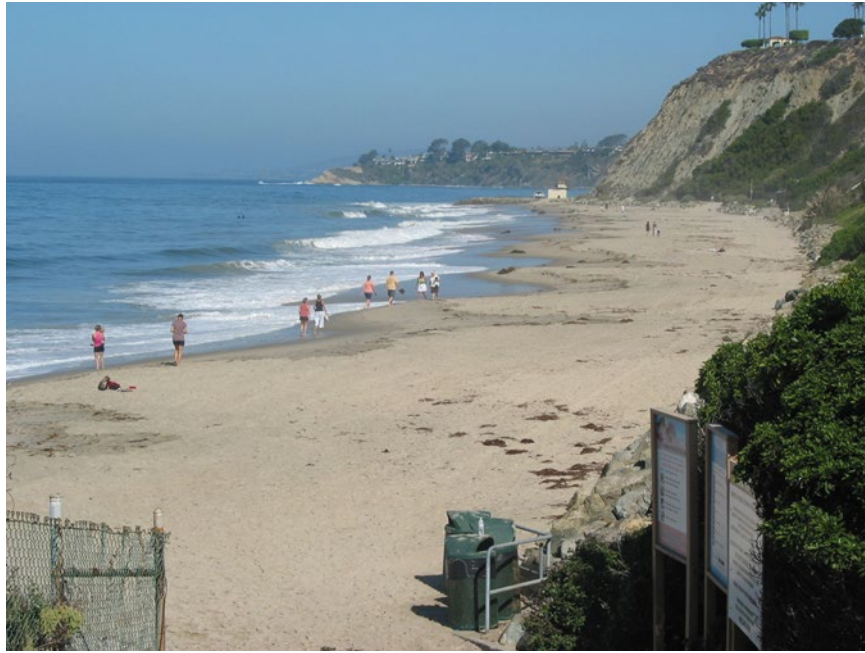
Typical Summer Beach Profile

Beach generally in a state of equilibrium with existing revetment - no evident long-term trends of shoreline erosion or accretion

Dynamic beach environment with significant changes in shoreline profile between summer and winter

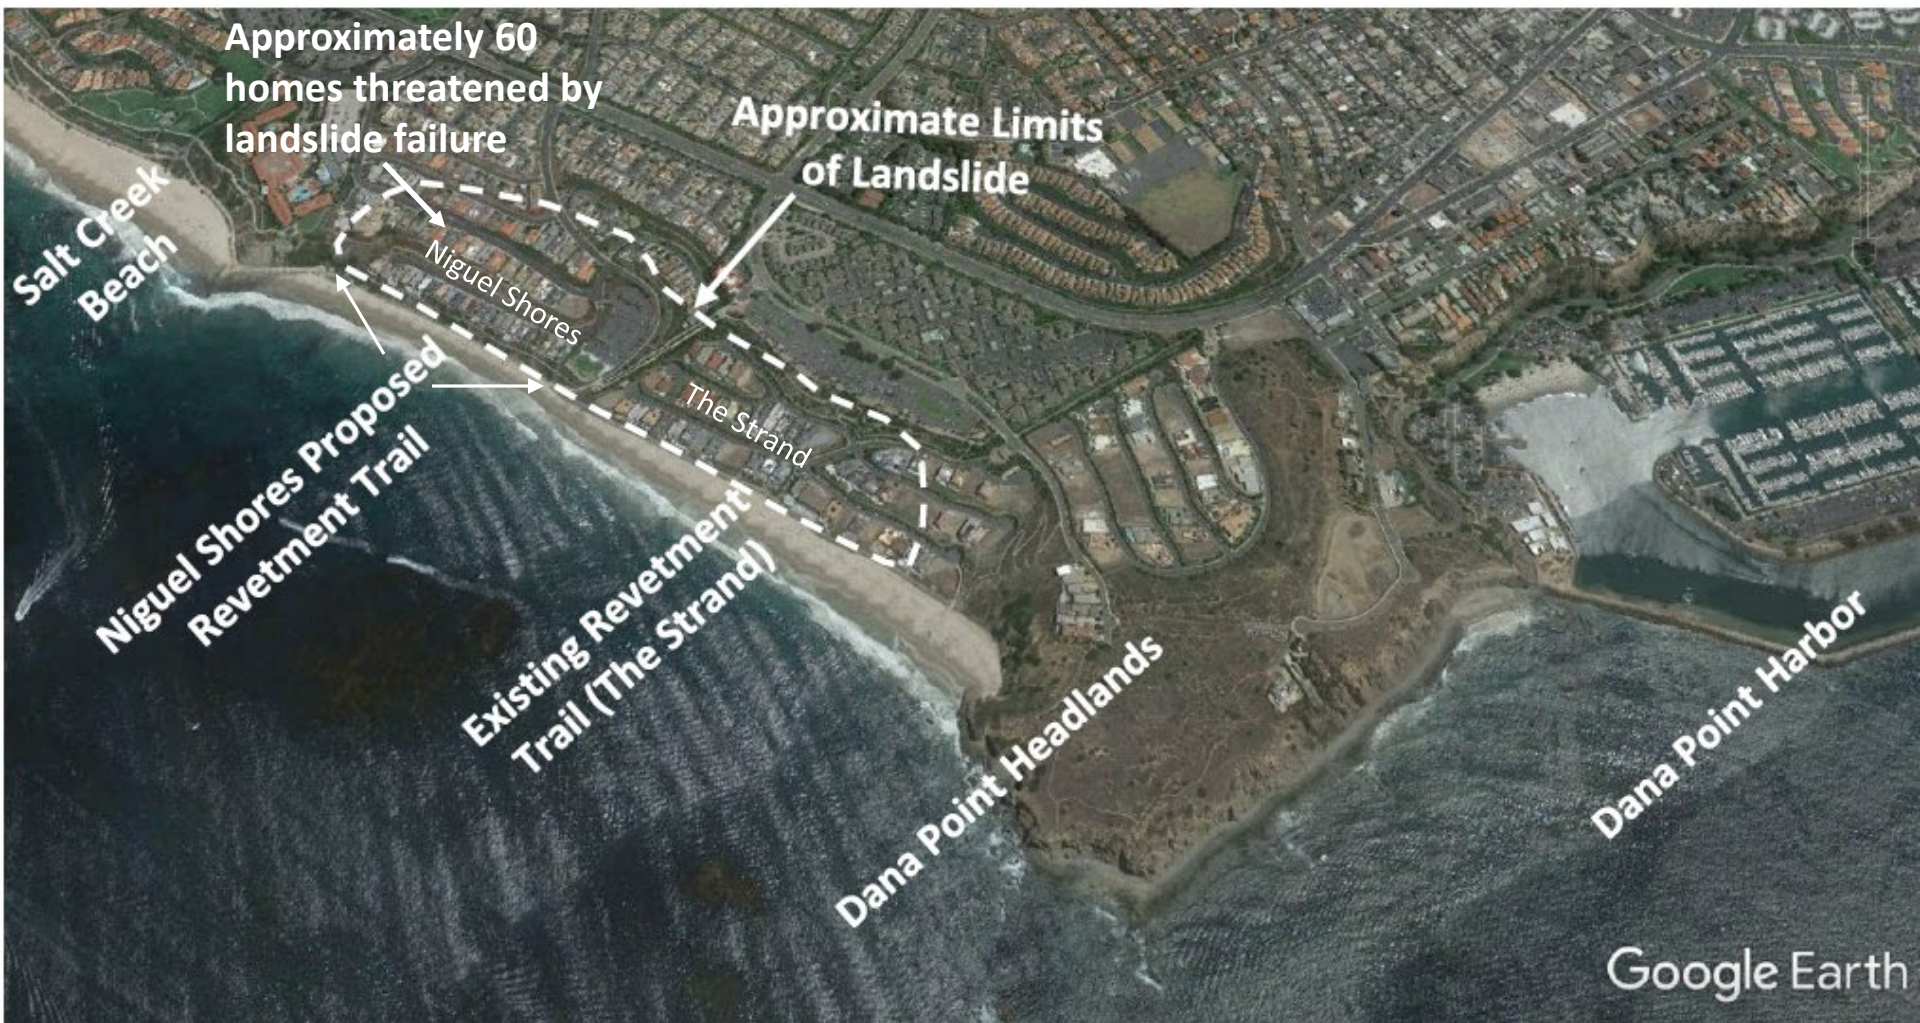
Pre-Coastal revetment necessary to protect existing development from extensive landslide hazard

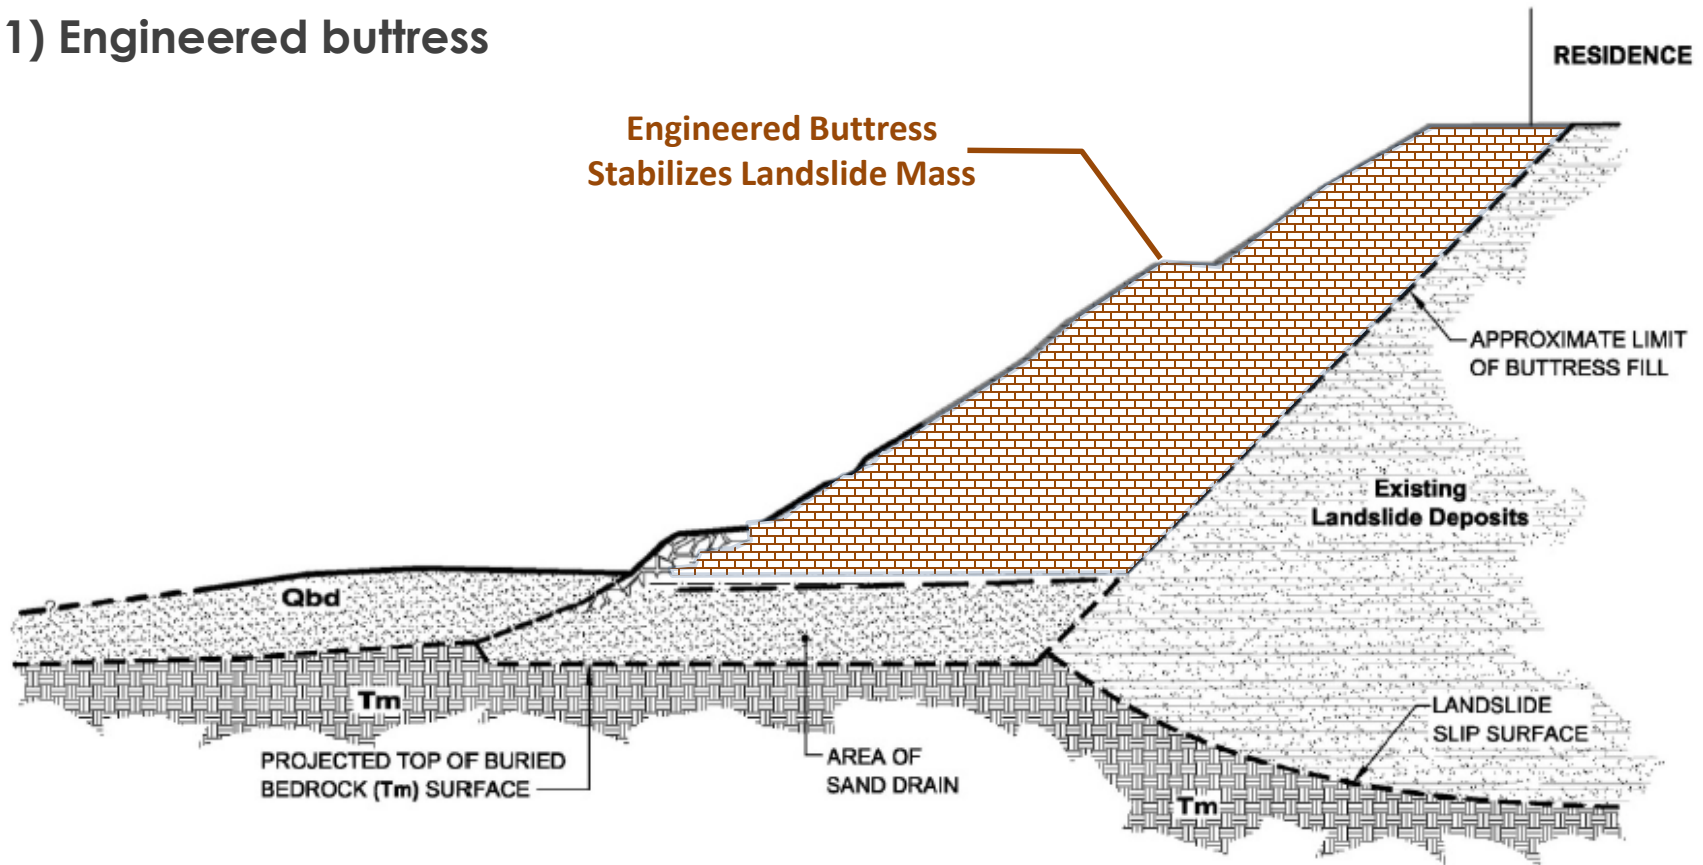
Figure 10

Landslide stabilization system must remain intact to prevent failure during and after construction:

1) Engineered buttress

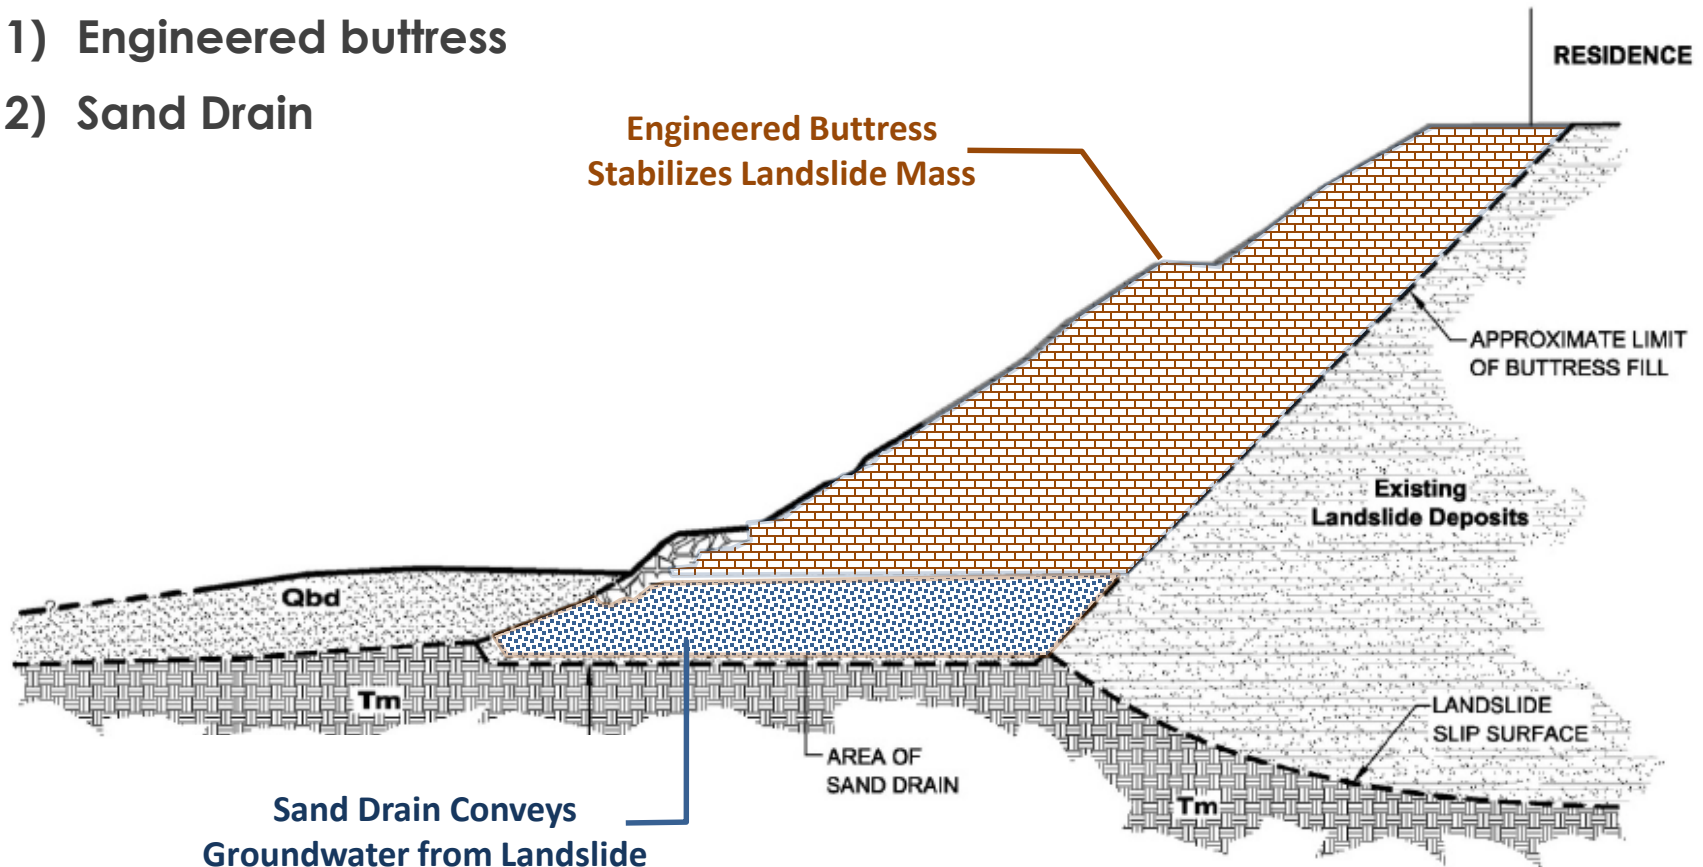
Figure 10

Landslide stabilization system must remain intact to prevent failure during and after construction:

- 1) Engineered buttress
- 2) Sand Drain

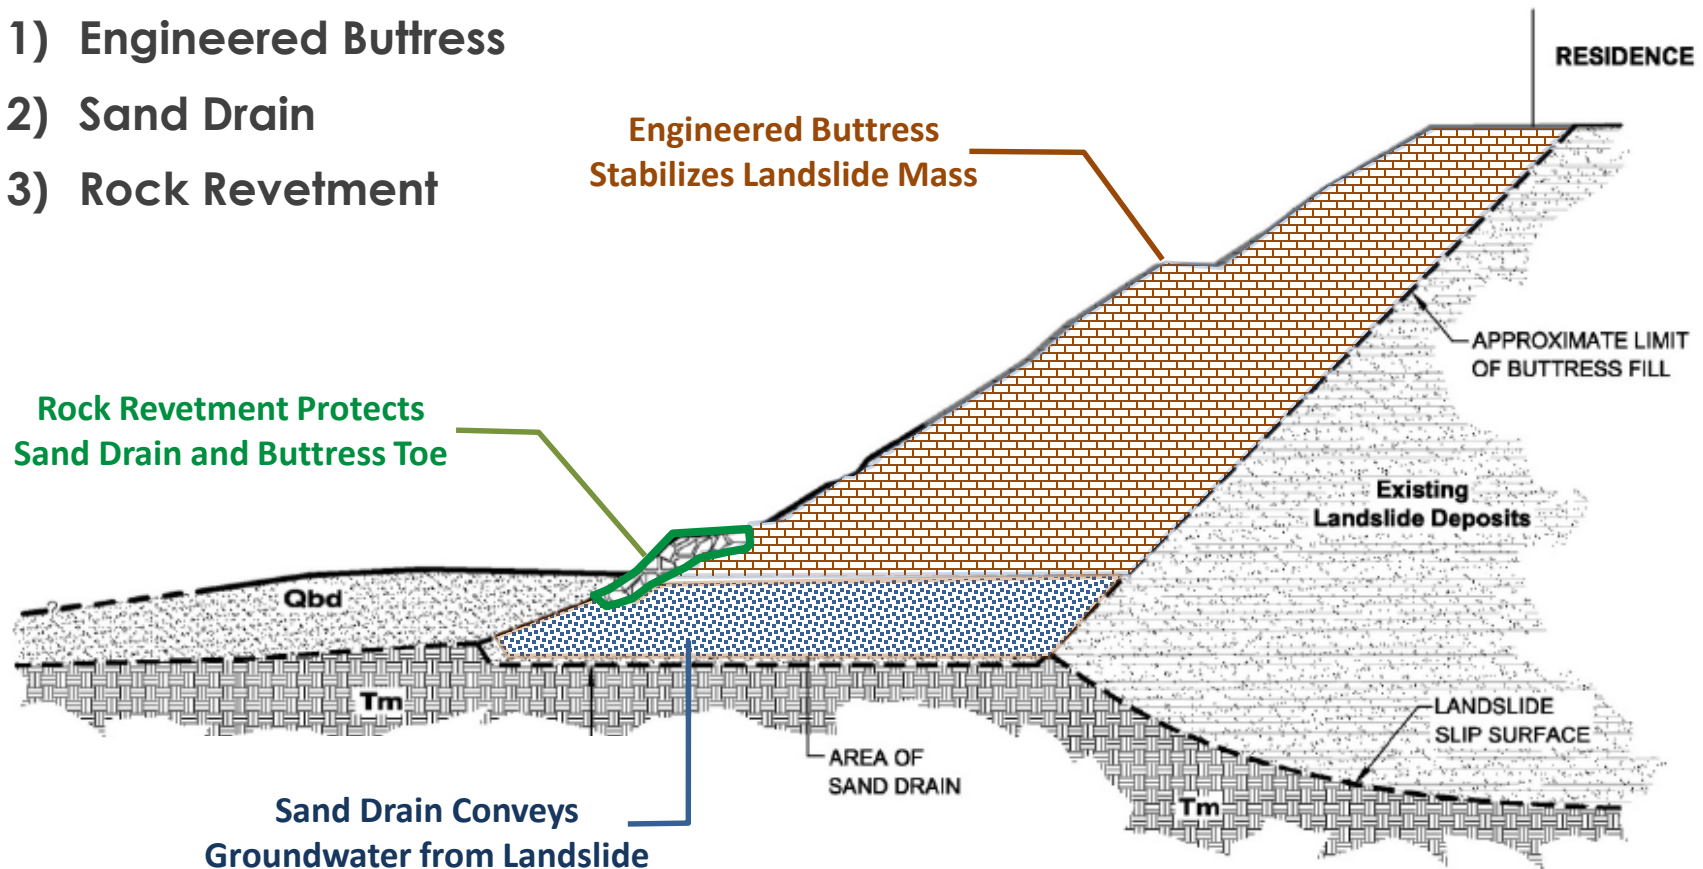
Figure 10

Landslide stabilization system must remain intact to prevent failure during and after construction:

- 1) Engineered Buttress
- 2) Sand Drain
- 3) Rock Revetment

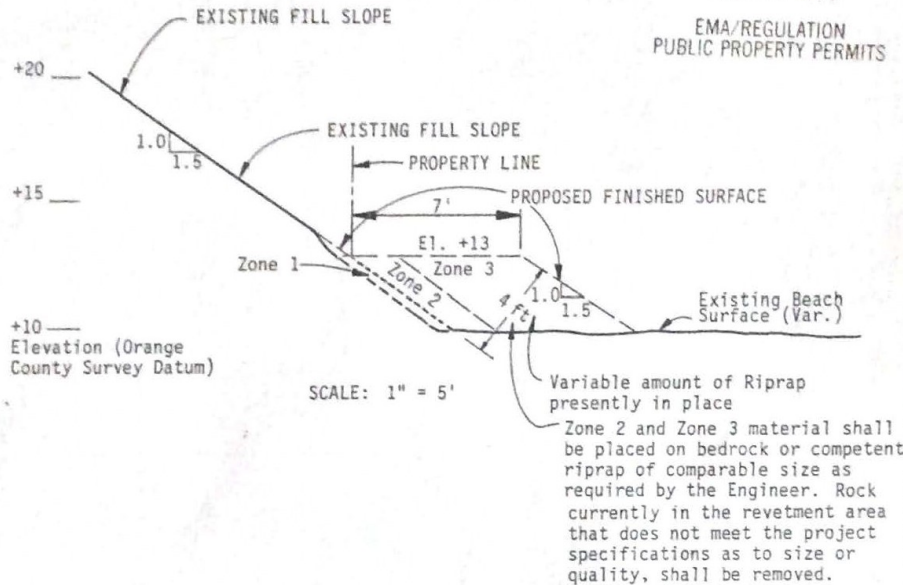
REVETMENT RESTORATION-TYPICAL DETAIL

1988 Revetment Repair

1. Zone 1 material: 5-20 lb. stone.
2. Zone 2 material: 200-400 lb. stone.
3. Zone 3 material: 1.0-1.5 ton stone.
4. A minimum of 6" of Zone 1 material shall be placed between existing fill material and Zone 2 material, or as required by the Engineer.
5. A minimum of 1 foot of Zone 2 material shall be placed between Zone 1 and Zone 3 material.
6. Filter fabric shall be installed between existing fill/beach surface and Zone 1 material, or as required by the Engineer. Upper portion of filter fabric shall be buried in trench at least 12 inches beneath finished surface. Backfill material shall be compacted to a minimum of 90% of relative compaction (ASTM D1557).
7. See Project Specifications for additional requirements.

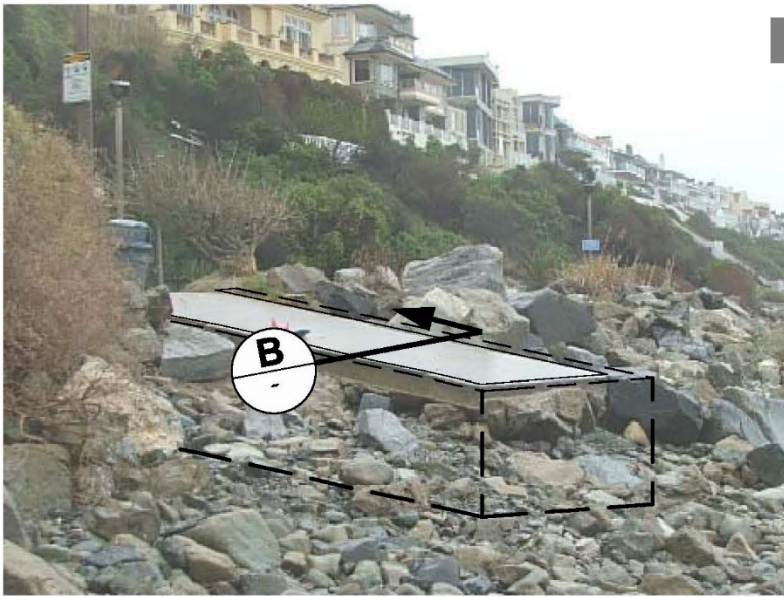
**EXISTING SOUTH ACCESS RAMP-
NORTH RAMP AND NORTH STAIRS SIMILAR**

Proposed repair plan also includes repair/stabilization of the north and south access ramps, and north stairs.

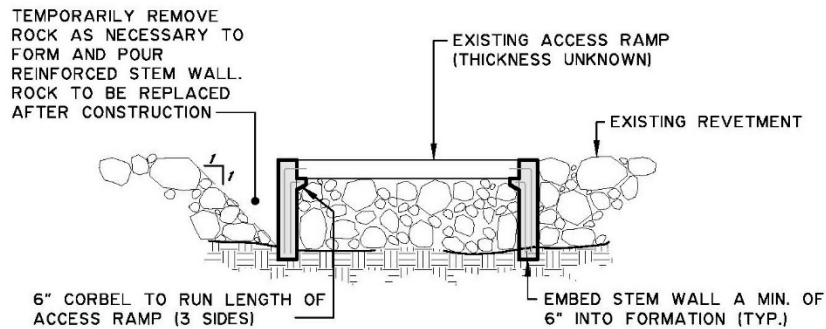
**TYPICAL CROSS SECTION
THRU NORTH & SOUTH ACCESS RAMPS**

SCALE: 1"=5'
